Case Study

Thickening Technology

**We provided a new drive
and bridge for a disintegrating
concrete thickener tank**

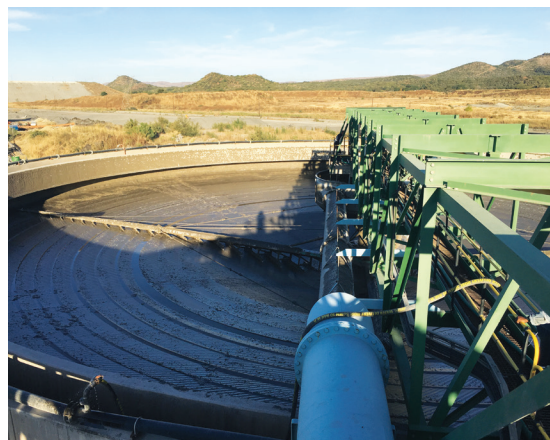
The customer's thickener was constructed in 2011 with the tank manufactured from concrete. The design was that of a centre column with a half span bridge. The bridge was supported on one end at the edge of the thickener, the other on the centre column in the middle of the thickener tank.

The concrete centre columns started to disintegrate which would mean that the thickener drive and internals would potentially collapse. This in turn would mean, a plant stoppage with millions in lost revenue.

- In stepped MIP Process.
- MIP Process designed a new bridge to go over the Completed tank.
- A full span bridge (45m long) and a new modern five-stage planetary gearbox was supplied.

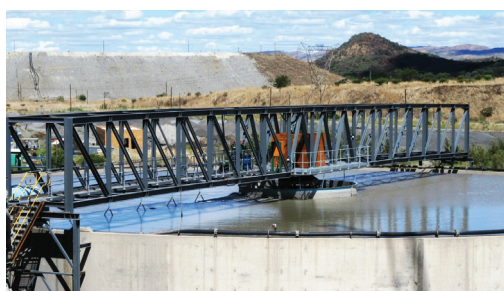
The end result was a thickener operating at much lower torque and producing higher and more consistent underflow density.
