Rust Conversion Restoration and Thermal Coating System

### **Rust Conversion restoration coating system**

**Project Site: PROBIOTEC PTY LTD**

**Project Address: 83 Cherry Lane – Laverton North**

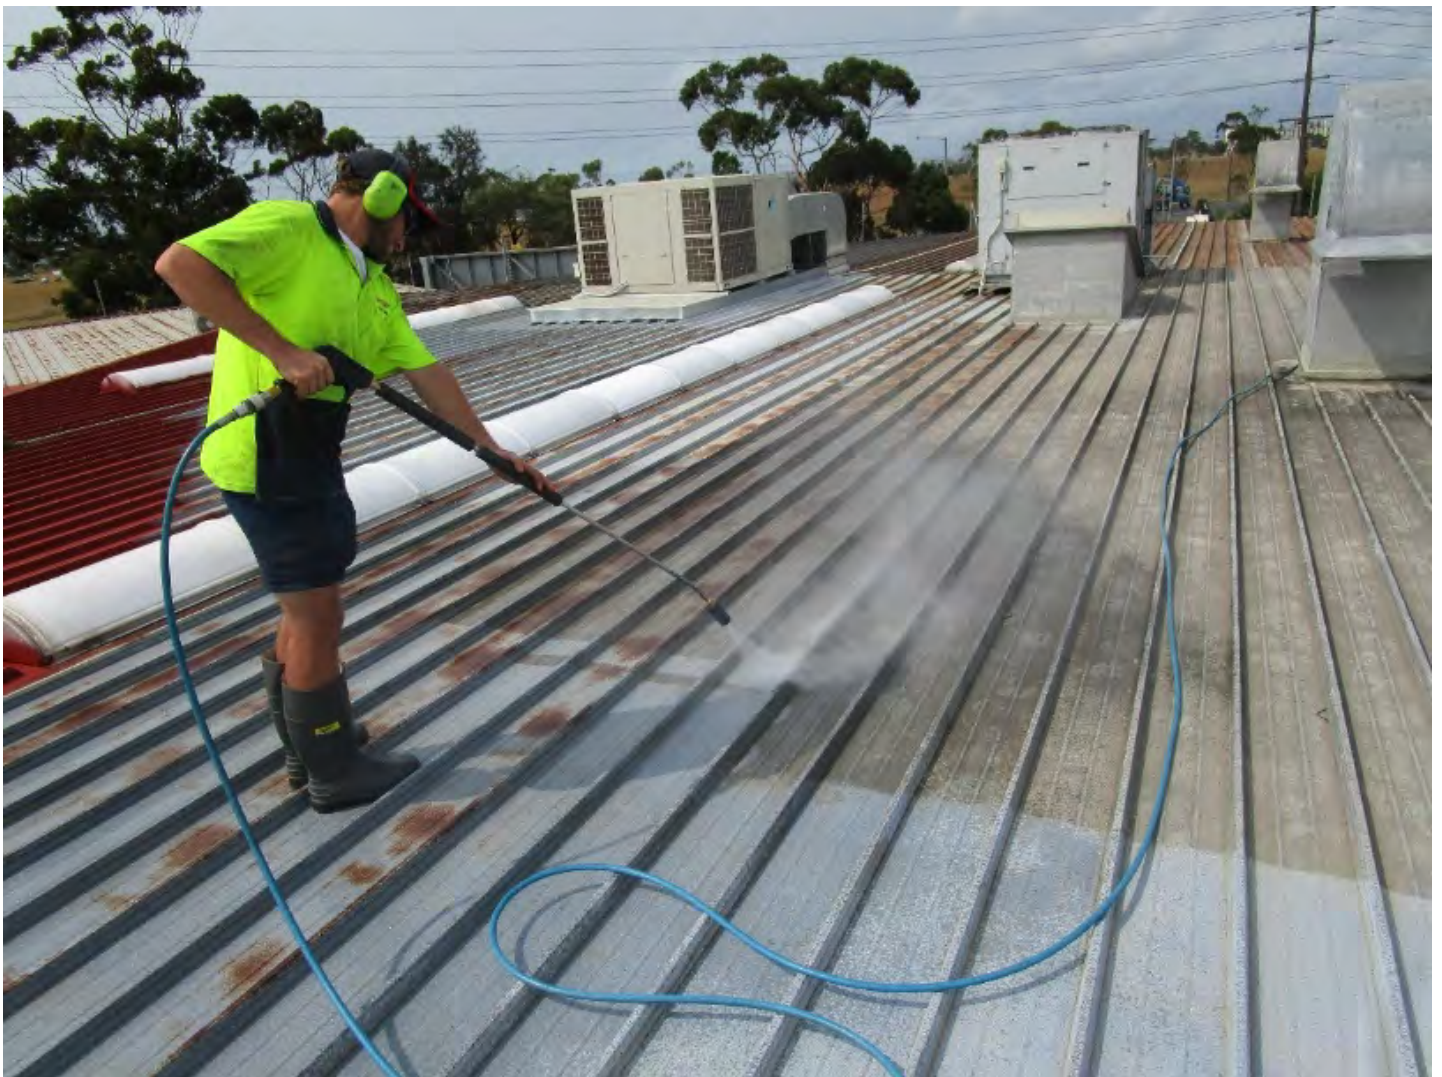
All grime and rust flakes were removed under high pressure water to ensure the rust converter made contact to the rust itself, not rust flakes or a layer of dirt.

You can see from the below photographs there is a clear line showing where the dirt/grime layer has been removed and bare metal is exposed.

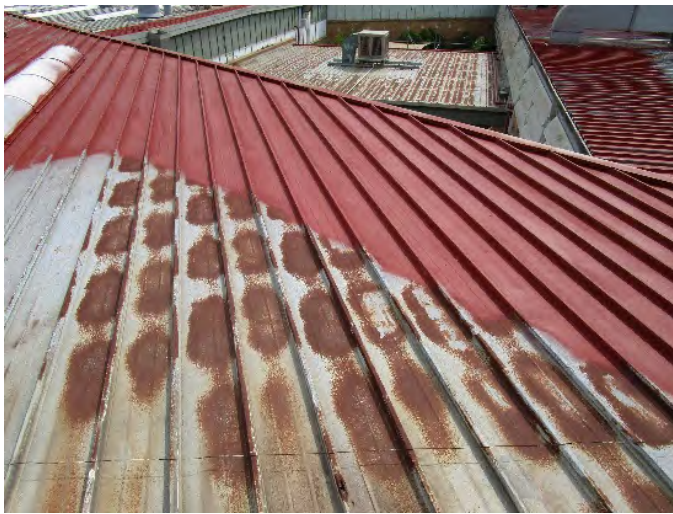
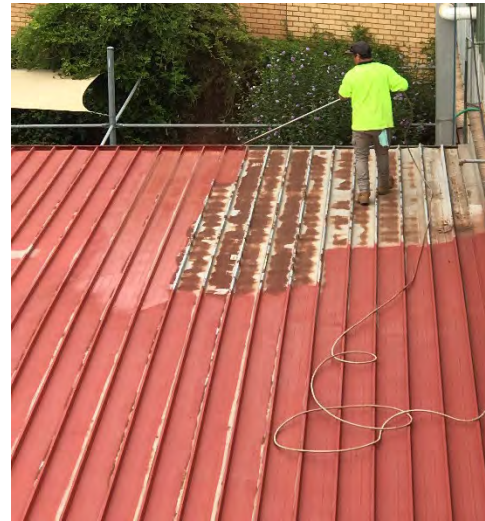
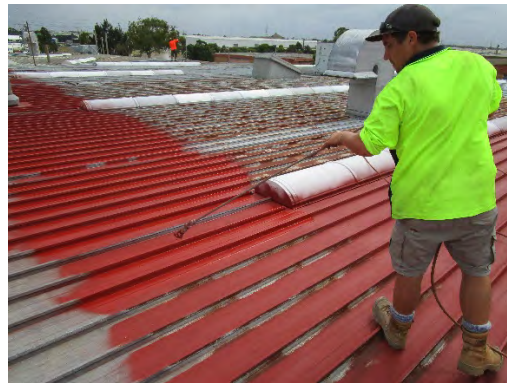
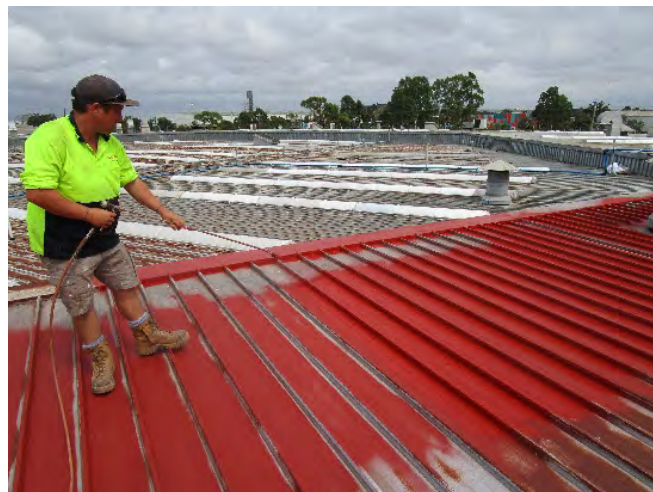
## **RUST CONVERSION:**

The rust convertor is applied to rusted steel only and not clean steel.

Our rust converting primer of choice has a lower pH and this enables it to be applied directly over rusted steel where the converting action turns all the rust (namely the mixed iron oxides and hydrated oxides) into a stable metal phosphate whilst simultaneously forming a tough protective coating over the converted steel.

This is an irreversible reaction which leads to a permanent rust conversion if correct surface preparation and application occurs.

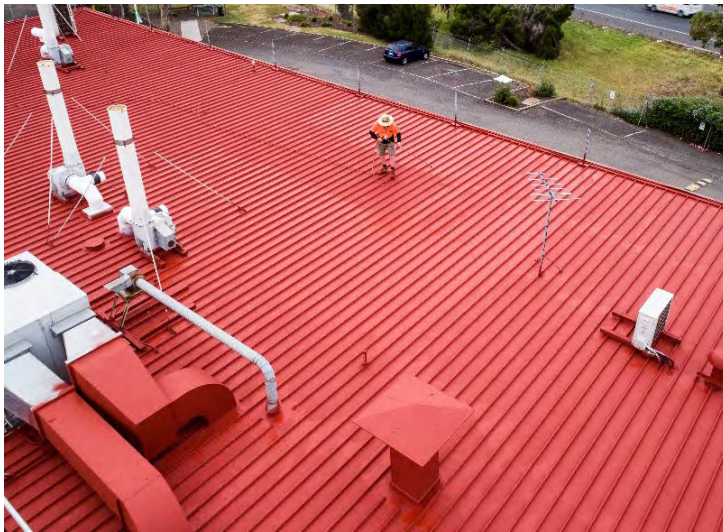
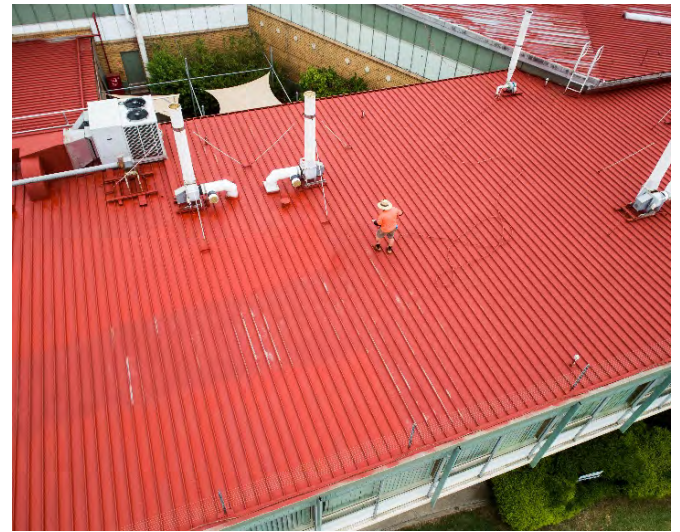
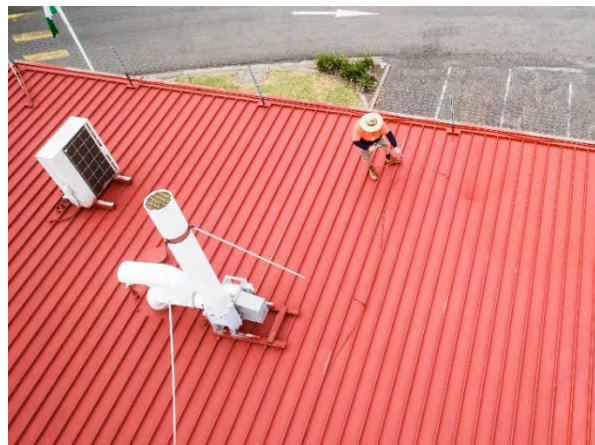
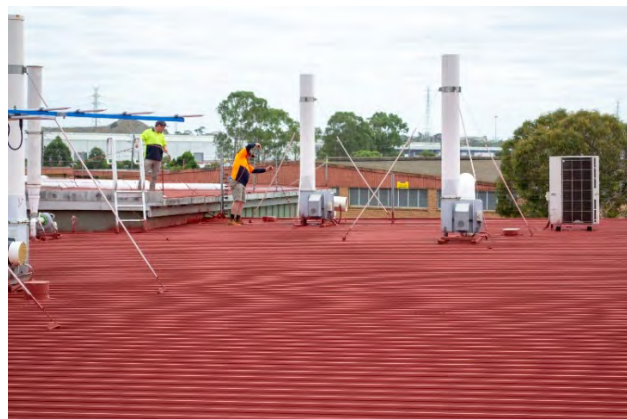
**BELOW ARE A SERIES OF PHOTOGRAPHS SHOWING THE APPLICATION STAGES OF RUST INHIBITOR**

Once rust has been converted to a stable metal phosphate within the paint film, a rust preventative primer coat is then applied.

This product is the “twin sister” to the rust converter which is designed mainly for application over well rusted steel. When the primer cures into an abrasion resistant skin it is impervious to further rust.

The primer coat, like the rust converter, is an acrylic based primer and is designed for application over the rust conversion layer to form a compatible finish. The primer (inhibitor) is applied to ALL METAL SURFACES (not just the rusted areas) prior to the protective topcoats of Thermoshield.

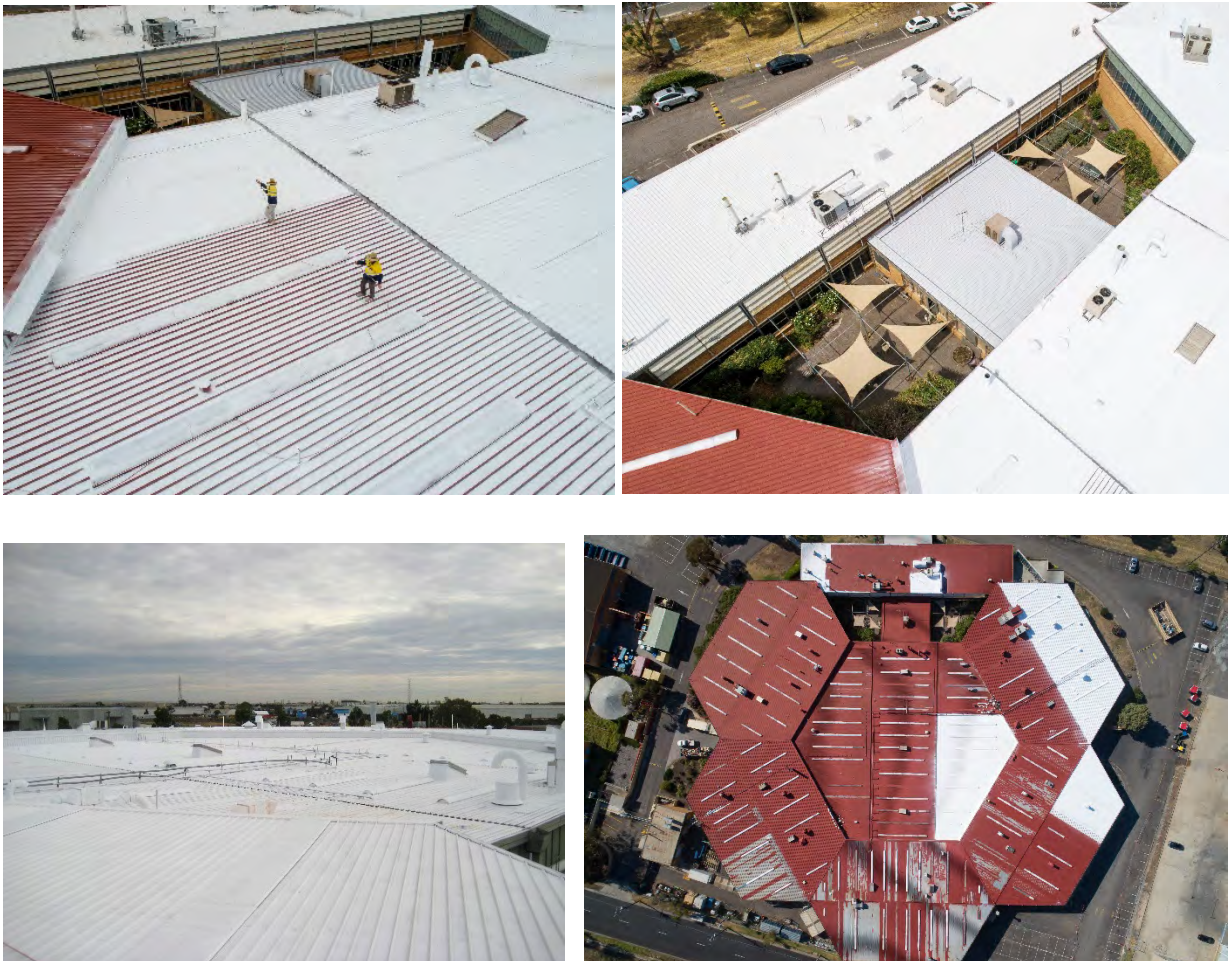
**FIRST COATING OF THERMOSHIELD**

Thermoshield thermal ceramic coating creates a thick non permeable membrane that acts to encase the converted metal, eliminating any and all environmental exposure.

Corrosion ultimately requires water and oxygen. Following permanent rust conversion, the metal is sealed beneath the thick 'blanket' of the Thermoshield ceramic coating eliminating water and oxygen exposure to the metal.

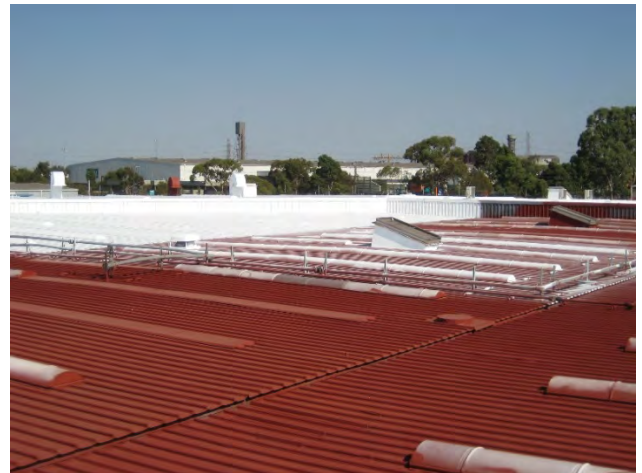
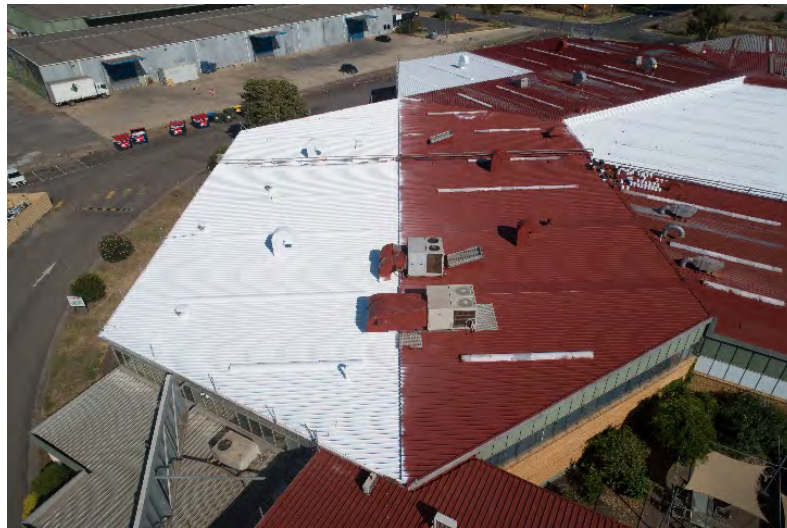
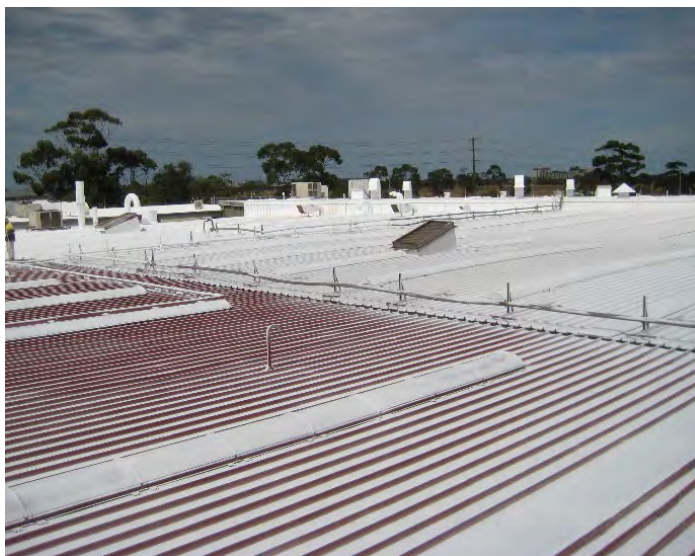
**FIRST COATING OF THERMOSHIELD / continuation**

Following rust conversion and primer (inhibitor) the acrylic Thermoshield adhesion to the acrylic rust converter and inhibitor is outstanding. All products contain phosphating action when drying.

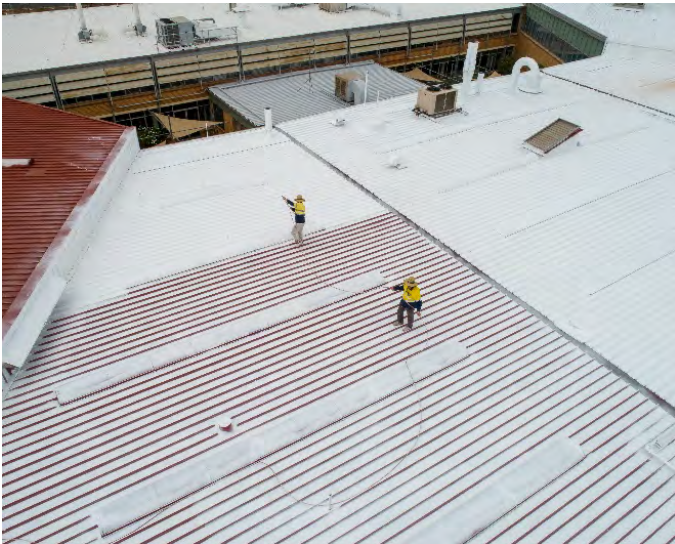
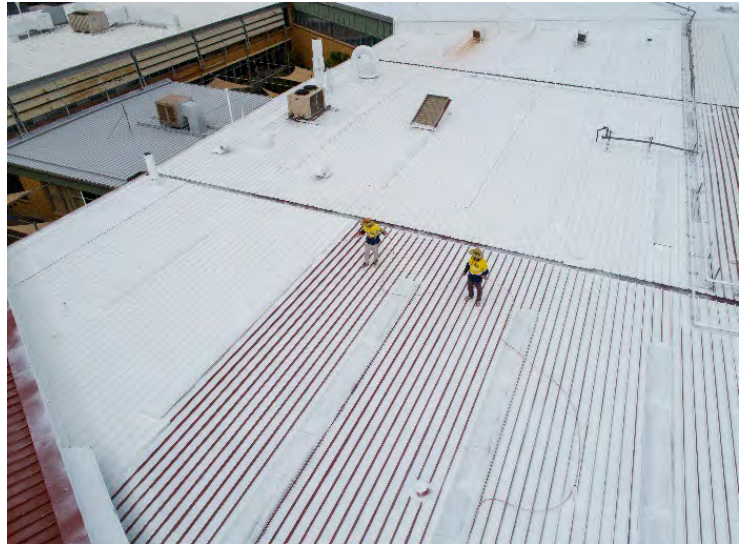
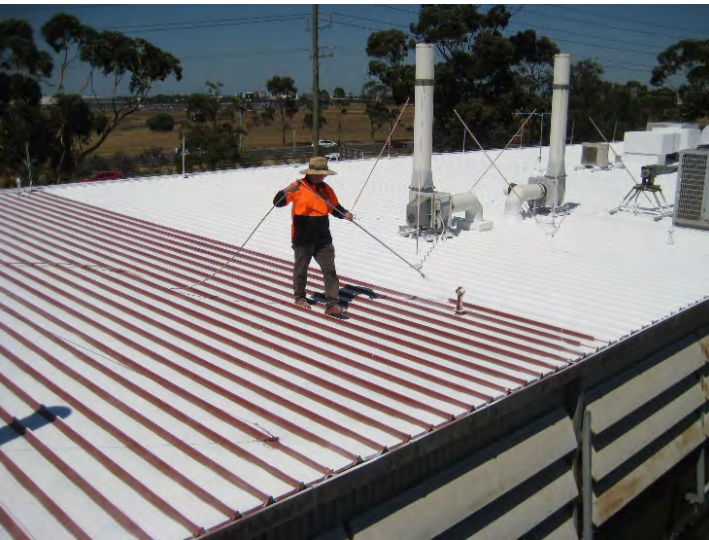
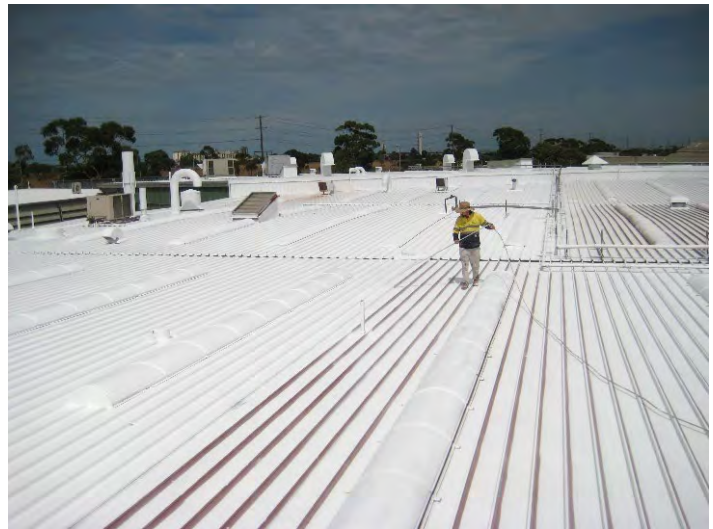
**SECOND COAT THERMOSHIELD**

The second coat was applied.

The product is extremely viscous, and this enables underlying colours, in this case the vivid red, to be completely covered.

This ensures maximum protection and evenness of membrane protection without weak links.

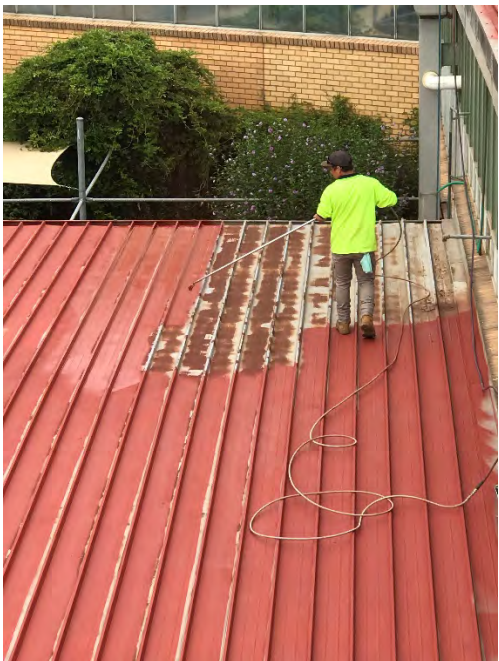
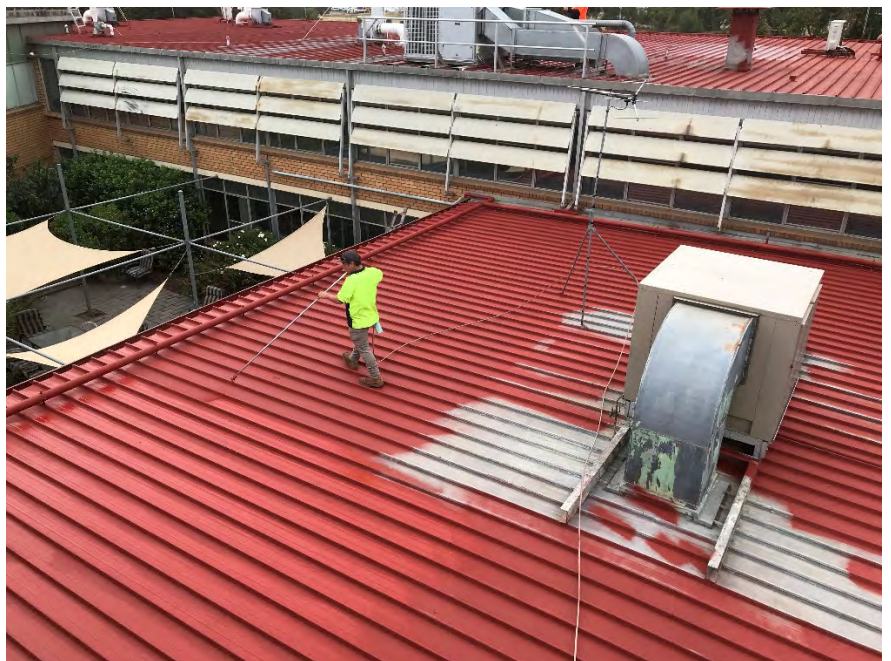
**ADDITIONAL AREA / CANTEEN ROOF**

It was decided as this roof is lower than the rest of the building and all the offices surround the canteen roof, that the reflection would be too great in the summer, therefore the decision was made to tint Thermoshield to Shale Grey to minimise the glare.
