# LOCTITE APPLICATION CASE HISTORY

No. 239

## Loctite<sup>®</sup> Retaining Compound Keeps Bucket Loader Moving; Increases Mine Production

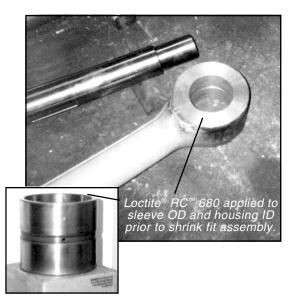
One application they identified was the bucket loader or "scoop." A scoop is like an excavating front end loading tractor, constantly loading 6-8 yards of earth. This heavy work load causes extreme shock and impact on the hinge arms and pin bearings of the bucket loader.

A shrink fit was used to insert the hinge pin bearings into the hinge arm, but surface imperfections on the bushing create space allowing for movement and corrosion over time. Every time the hinge pin bearings pounded out the housing, maintenance on the equipment was required. Mine engineers wanted to find a better way to secure the hinge pin bearings into the hinge arm that would increase in-service time for the bucket loader.

The worn hinges were machined to round and sized .002" smaller than the sleeve OD. All surfaces were cleaned with Loctite<sup>®</sup> 7070 ODC-Free Cleaner. After cooling the replacement sleeve, Loctite RC 680 was applied to the housing ID and the sleeve OD. The sleeve was slid into place and allowed to cure for 24 hours.

Augmenting the shrink fit with RC 680 completely filled any voids in the fit of the two parts. This added a significant amount of strength to the final assembly, enabling the bucket loader to stay in service longer.
